Aladdin Environmental LLC

March 26, 2008

Re: 114 Villa Grande, San Antonio, TX

Aladdin Environmental is pleased to submit this environmental evaluation on the above residence located at 114 Villa Grande, San Antonio, TX. This limited evaluation was performed on March 21st, 2008. We have observed the standard of care generally exercised by the profession under similar circumstances and conditions to complete this report.

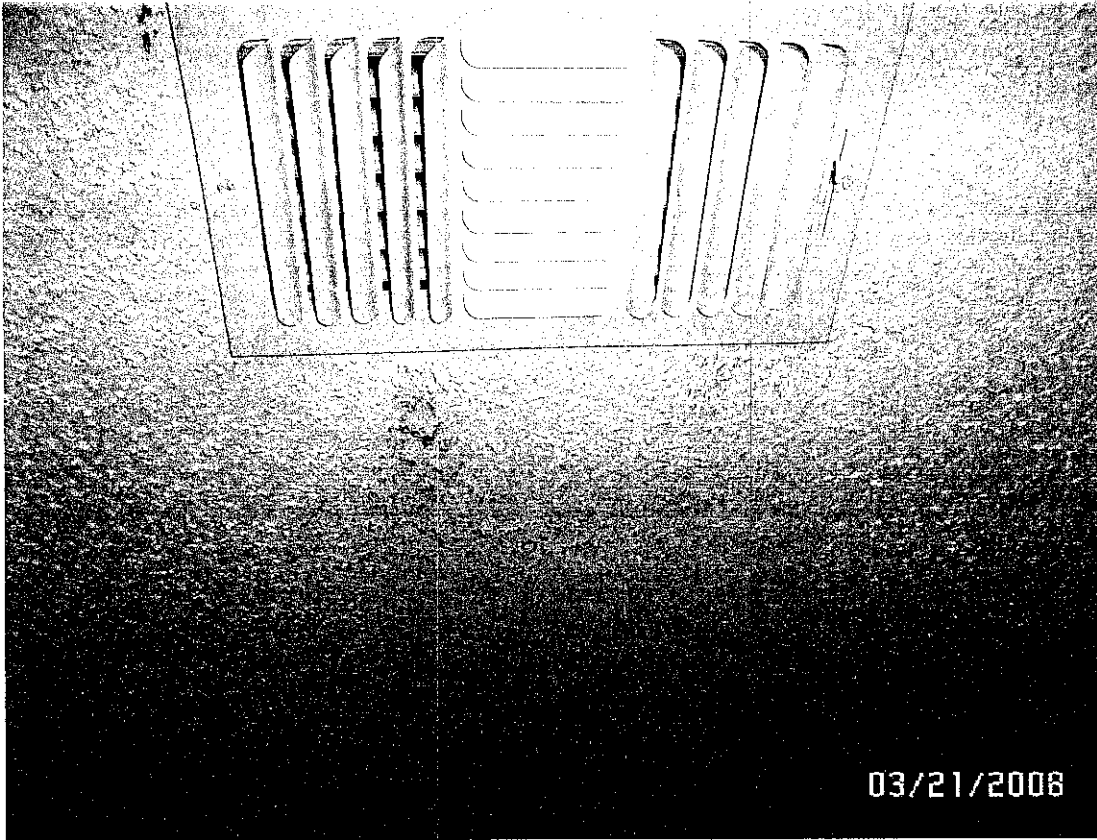
S1 – Living Room – ceiling near A/C vent

- A swab sample was taken on the sheetrock ceiling near the A/C vent. The lab results indicate "Rare" counts of various microbial spores.

- Recommend the door threshold be inspected and repaired as necessary.
 - Recommend replace the caulk around the window.
- Living Room – the windows had signs of possible minor microbial growth. The ceiling near the A/C vent had signs of debris that is listed in Swab sample S1.

Living - ceiling near A/C vent

- Recommend the ceiling near the A/C vent be HEPA vacuumed.
- Hall Bath – The edge of the toilet and tub at the floor had signs of excess caulk from what appears to be poor caulking.

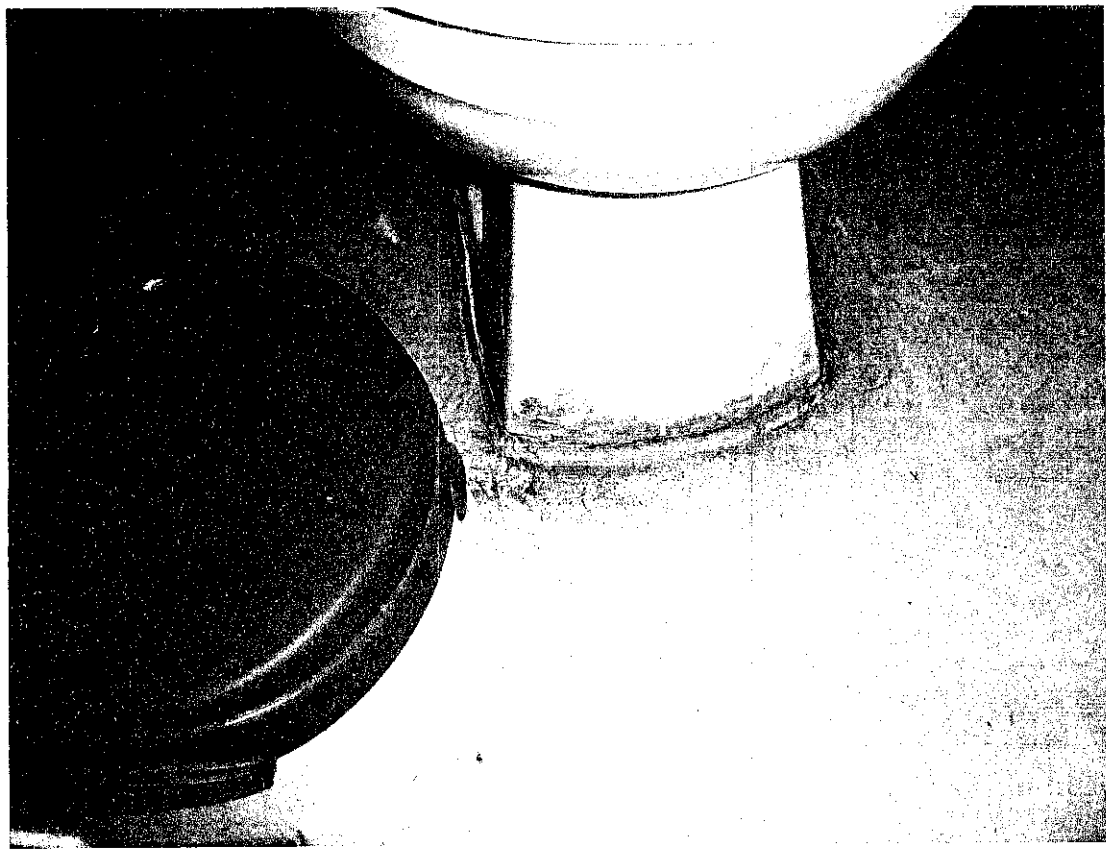
Hall Bath - toilet

- Recommend replacing the caulk around the base of the toilet and tub.
- Master Bedroom – The window had signs of possible minor microbial growth on the frame and caulk.

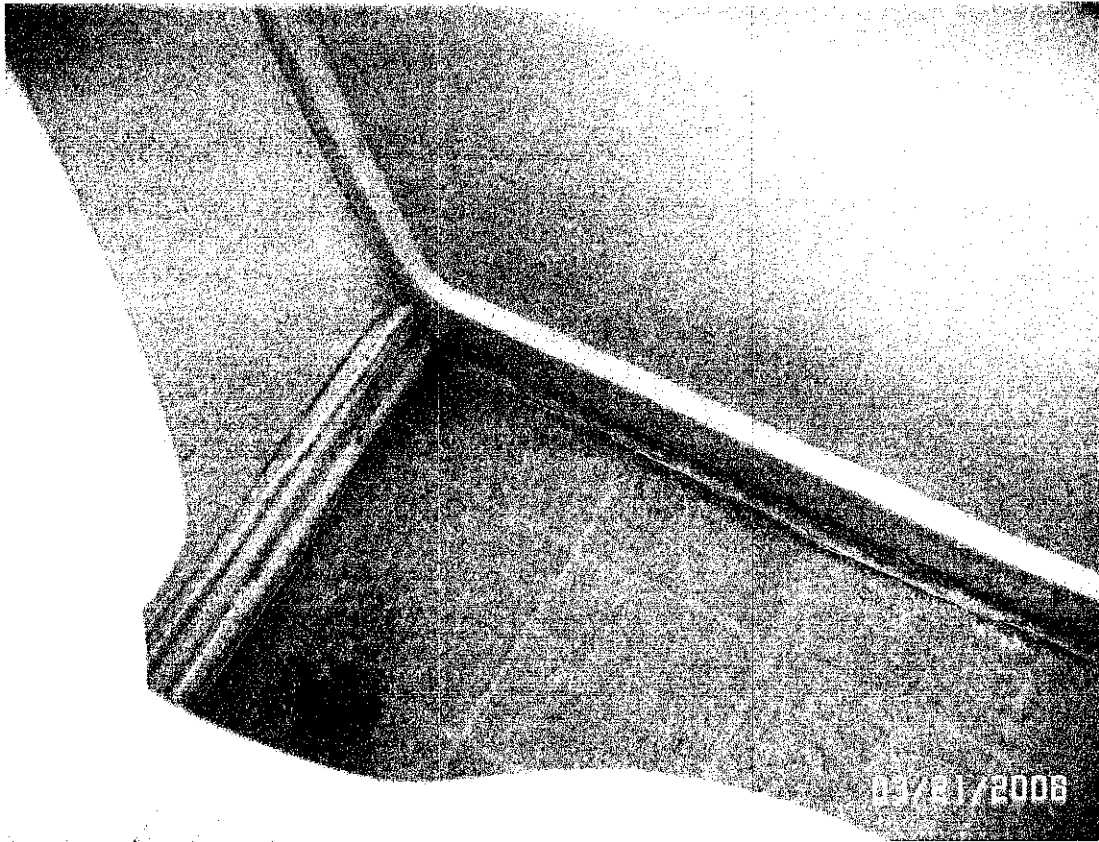
Hall Bath – tub

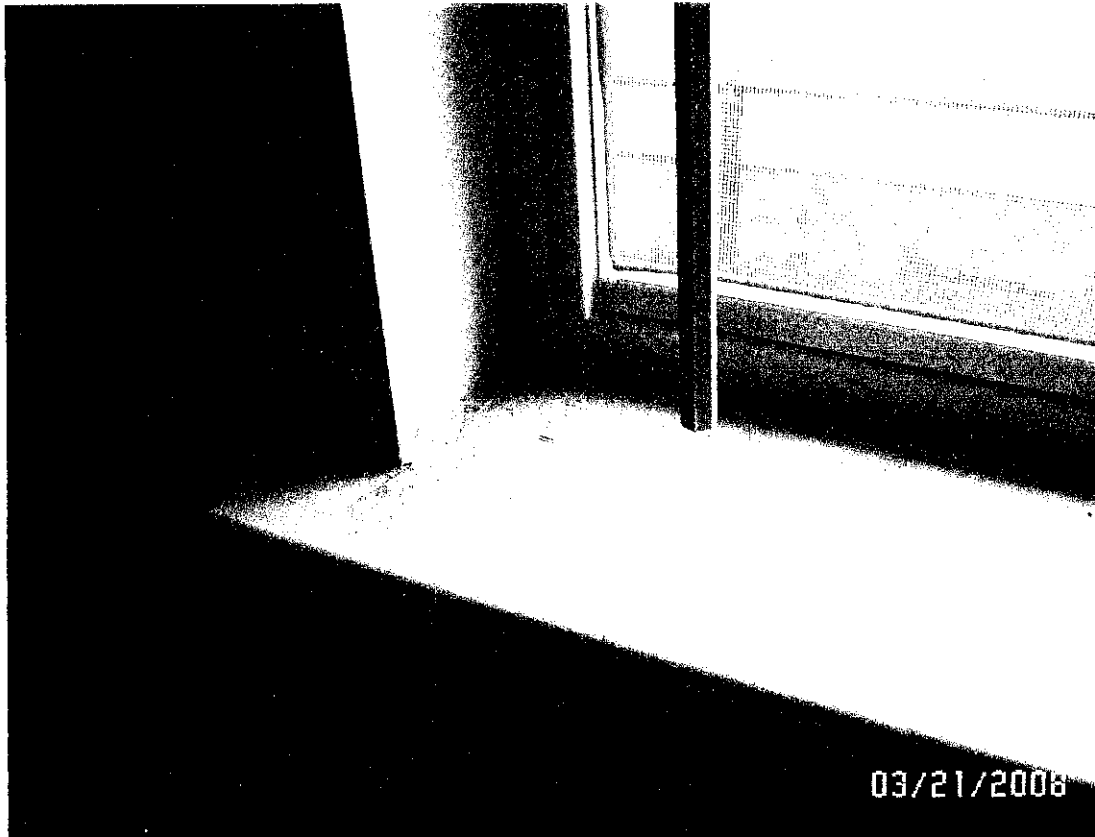
- Back Left Bedroom – The window had recently been replaced, but the remaining caulk showed signs of microbial growth.
 - Recommend the window sill be cleaned & sanitized and the caulk replaced properly.

- Recommend the window area be part of routine cleaning to prevent debris buildup.
- Front Left Bedroom – The window had recently been replaced, but the remaining caulk showed signs of microbial growth.

Bedroom - new window with old caulk

- Recommend the window sill be cleaned & sanitized and the caulk replaced properly.
 - Recommend the window area be part of routine cleaning to prevent debris buildup.
